## Chapter 3

# Affected Environment, Significant Impacts, and Mitigation Measures

#### 3.1 EARTH

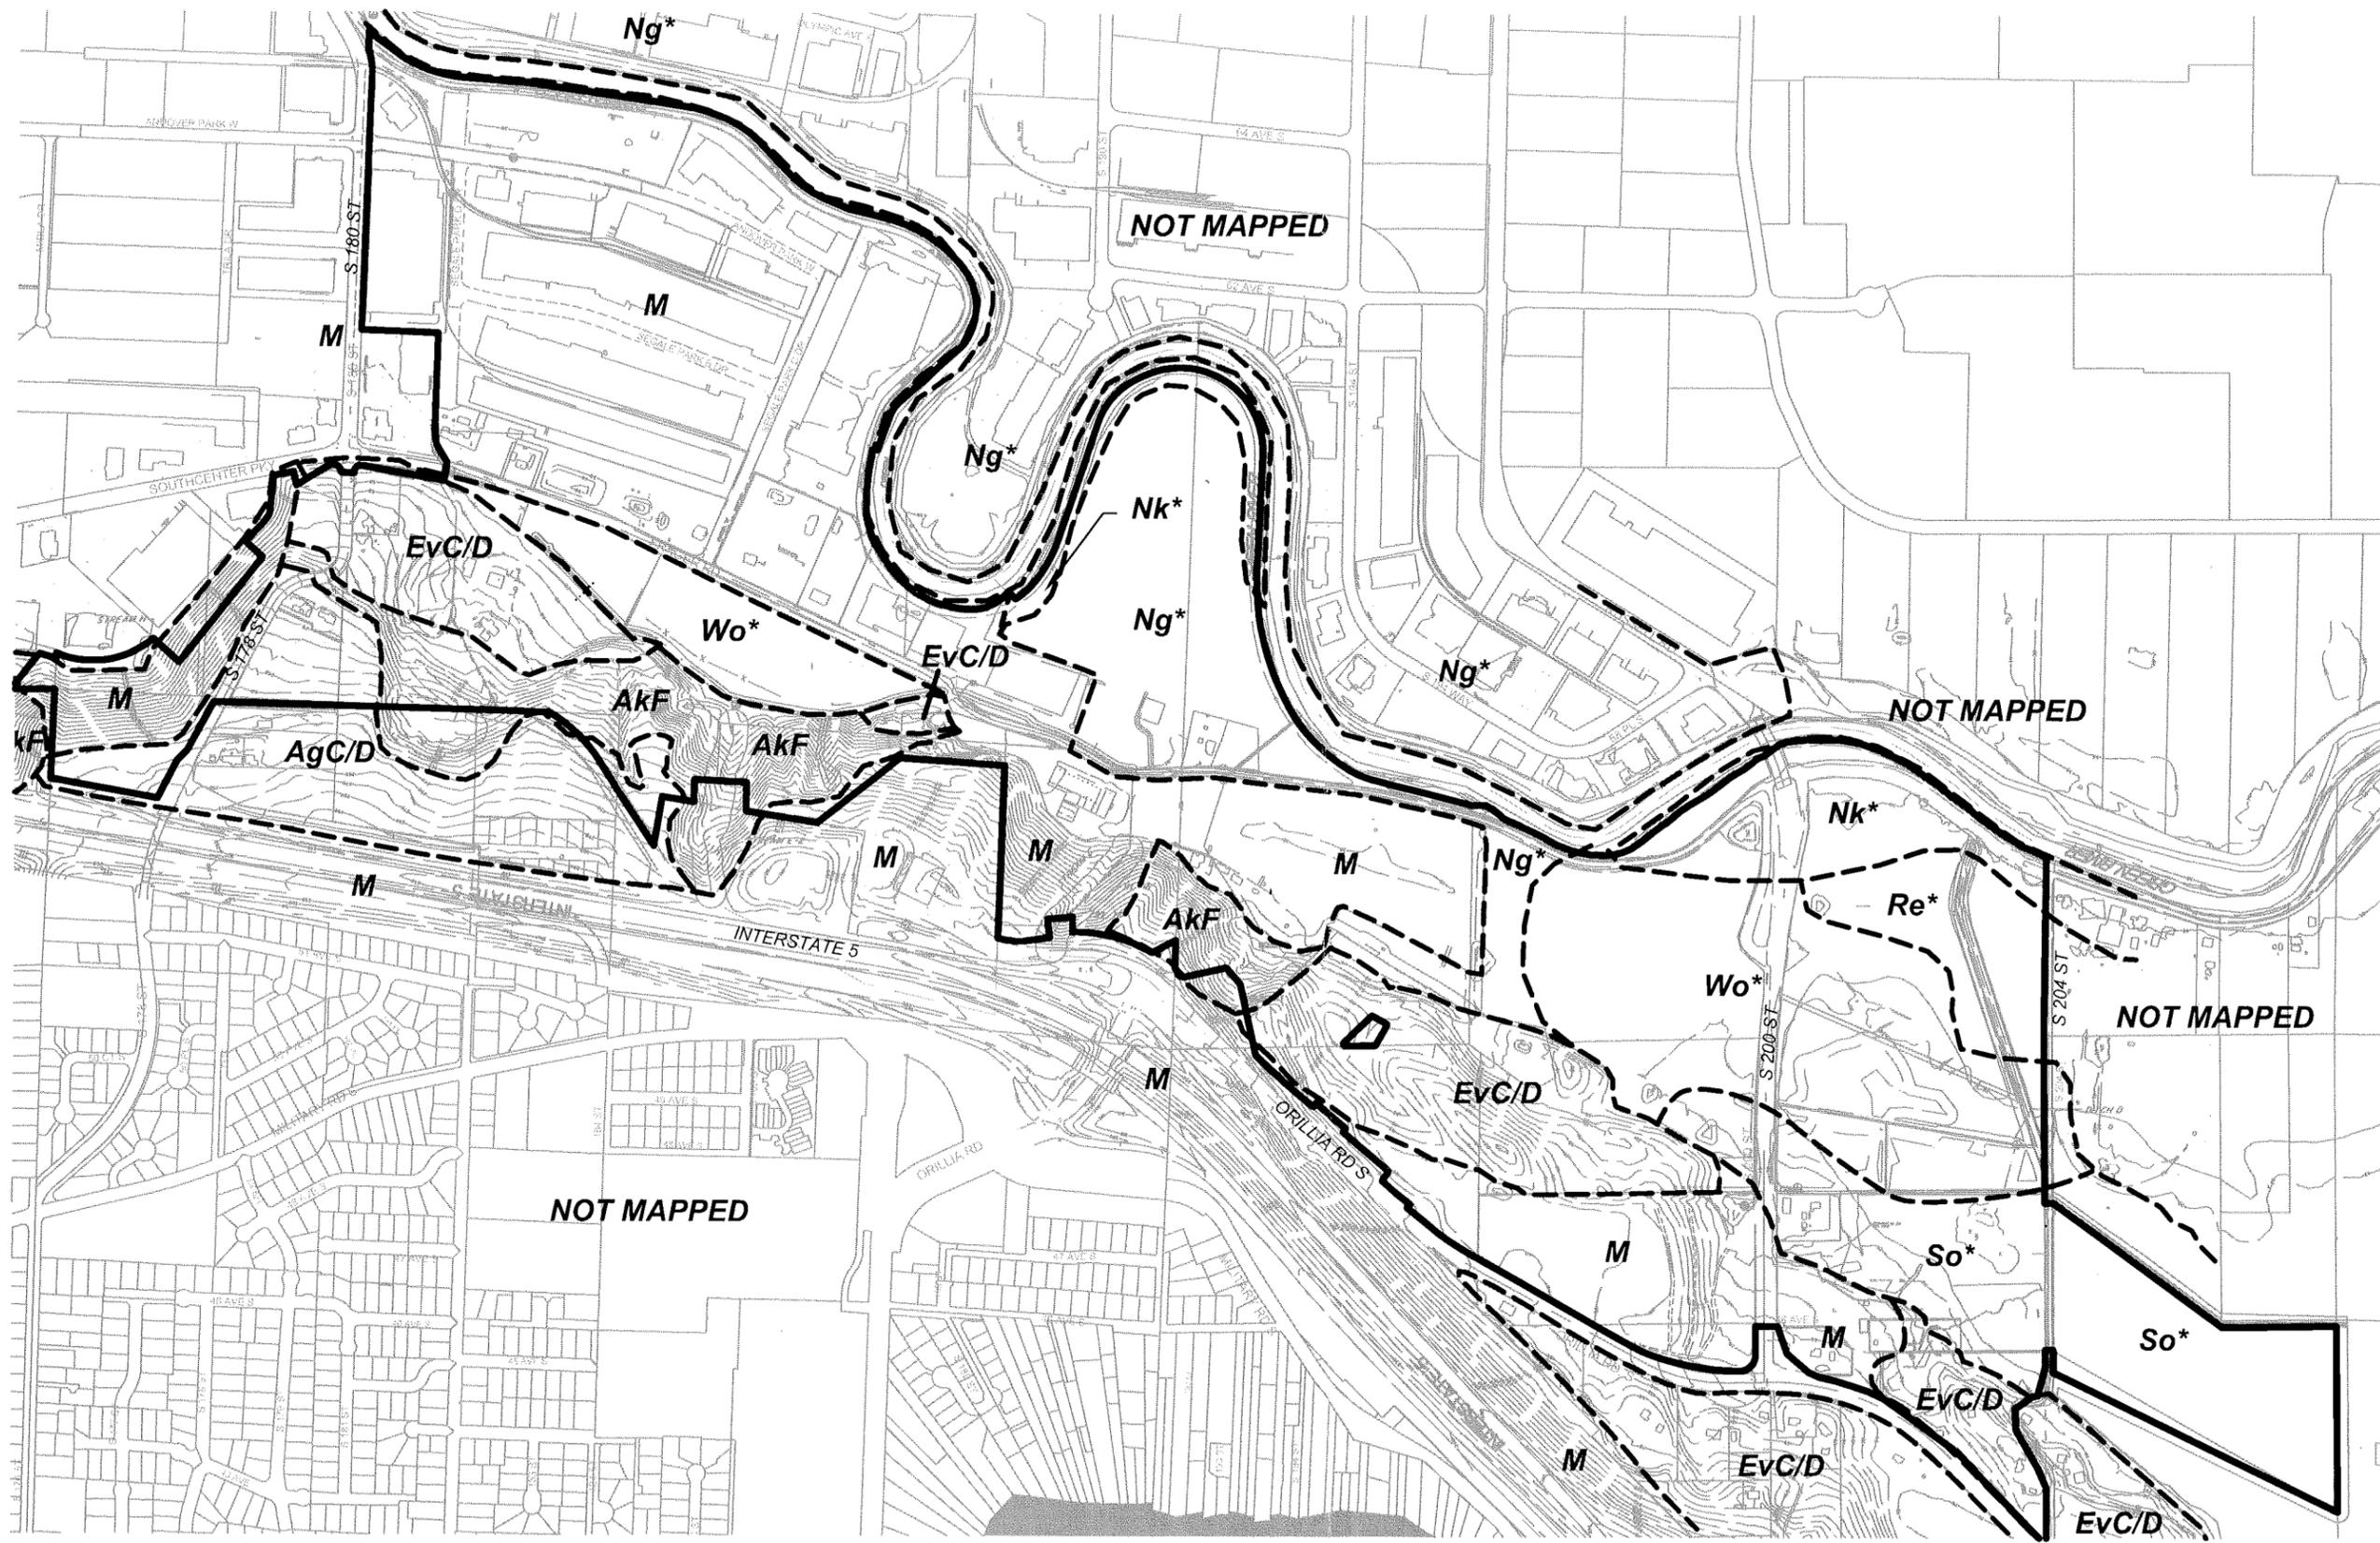
**LEGEND**

<b>AkF</b> Alderwood and Kitsap	<b>Ng</b> Newberg silt loam	<b>M</b> Modified land; includes former quarries and developed land; soils may be disturbed or absent	* May contain areas of Modified land developed since the soil survey of 1973
<b>AgC/D</b> Alderwood gravelly loam	<b>Nk</b> Nooksack silt loam	--- Soils mapping unit contact	
<b>EvC/D</b> Everett gravelly sandy loam	<b>So</b> Snohomish silt loam	— Project boundary	
<b>Wo</b> Woodinville silt loam	<b>Re</b> Renton silt loam

<b>Soil Name and Symbol</b>	<b>Parent Geologic Unit</b>	<b>USDA Textural Classification</b>	<b>Percent Slope</b>	<b>Permeability</b>	<b>Runoff Rate</b>	<b>Erosion Hazard</b>
Alderwood and Kitsap (Akf)	Qvt/ Qpog/ Qpog <sub>t</sub>	Gravelly sandy loam and silt loam	25-70	Varies	Rapid to very rapid	Severe to very severe
Arent, Alderwood (Amc)	Qvt/ Qpog/ Qpog <sub>t</sub>	Gravelly sandy loam	6-15	Varies	Medium	Moderate to severe
Alderwood Gravelly Loam (AgC)	Qvt/ Qpog/ Qpog <sub>t</sub>	Gravelly sandy loam	6-15	Moderately Rapid	Slow to medium	Low to moderate
Alderwood Gravelly Sandy Loam (AgD)	Qvt/ Qpog/ Qpog <sub>t</sub>	Gravelly sandy loam	15-30	Moderately Rapid	Medium	Severe
Everett Gravelly Sandy Loam (Evc)	Qvic	Gravelly sandy loam	5-15	Rapid	Slow to medium	Slight to moderate
Everett Gravelly Sandy Loam (EvD)	Qvic	Gravelly sandy loam	15-30	Rapid	Medium to rapid	Moderate to Severe
Woodinville Silt Loam (Wo)	Qal	Silt loam to silty clay loam	0-2	Moderately Slow	Slow	Slight

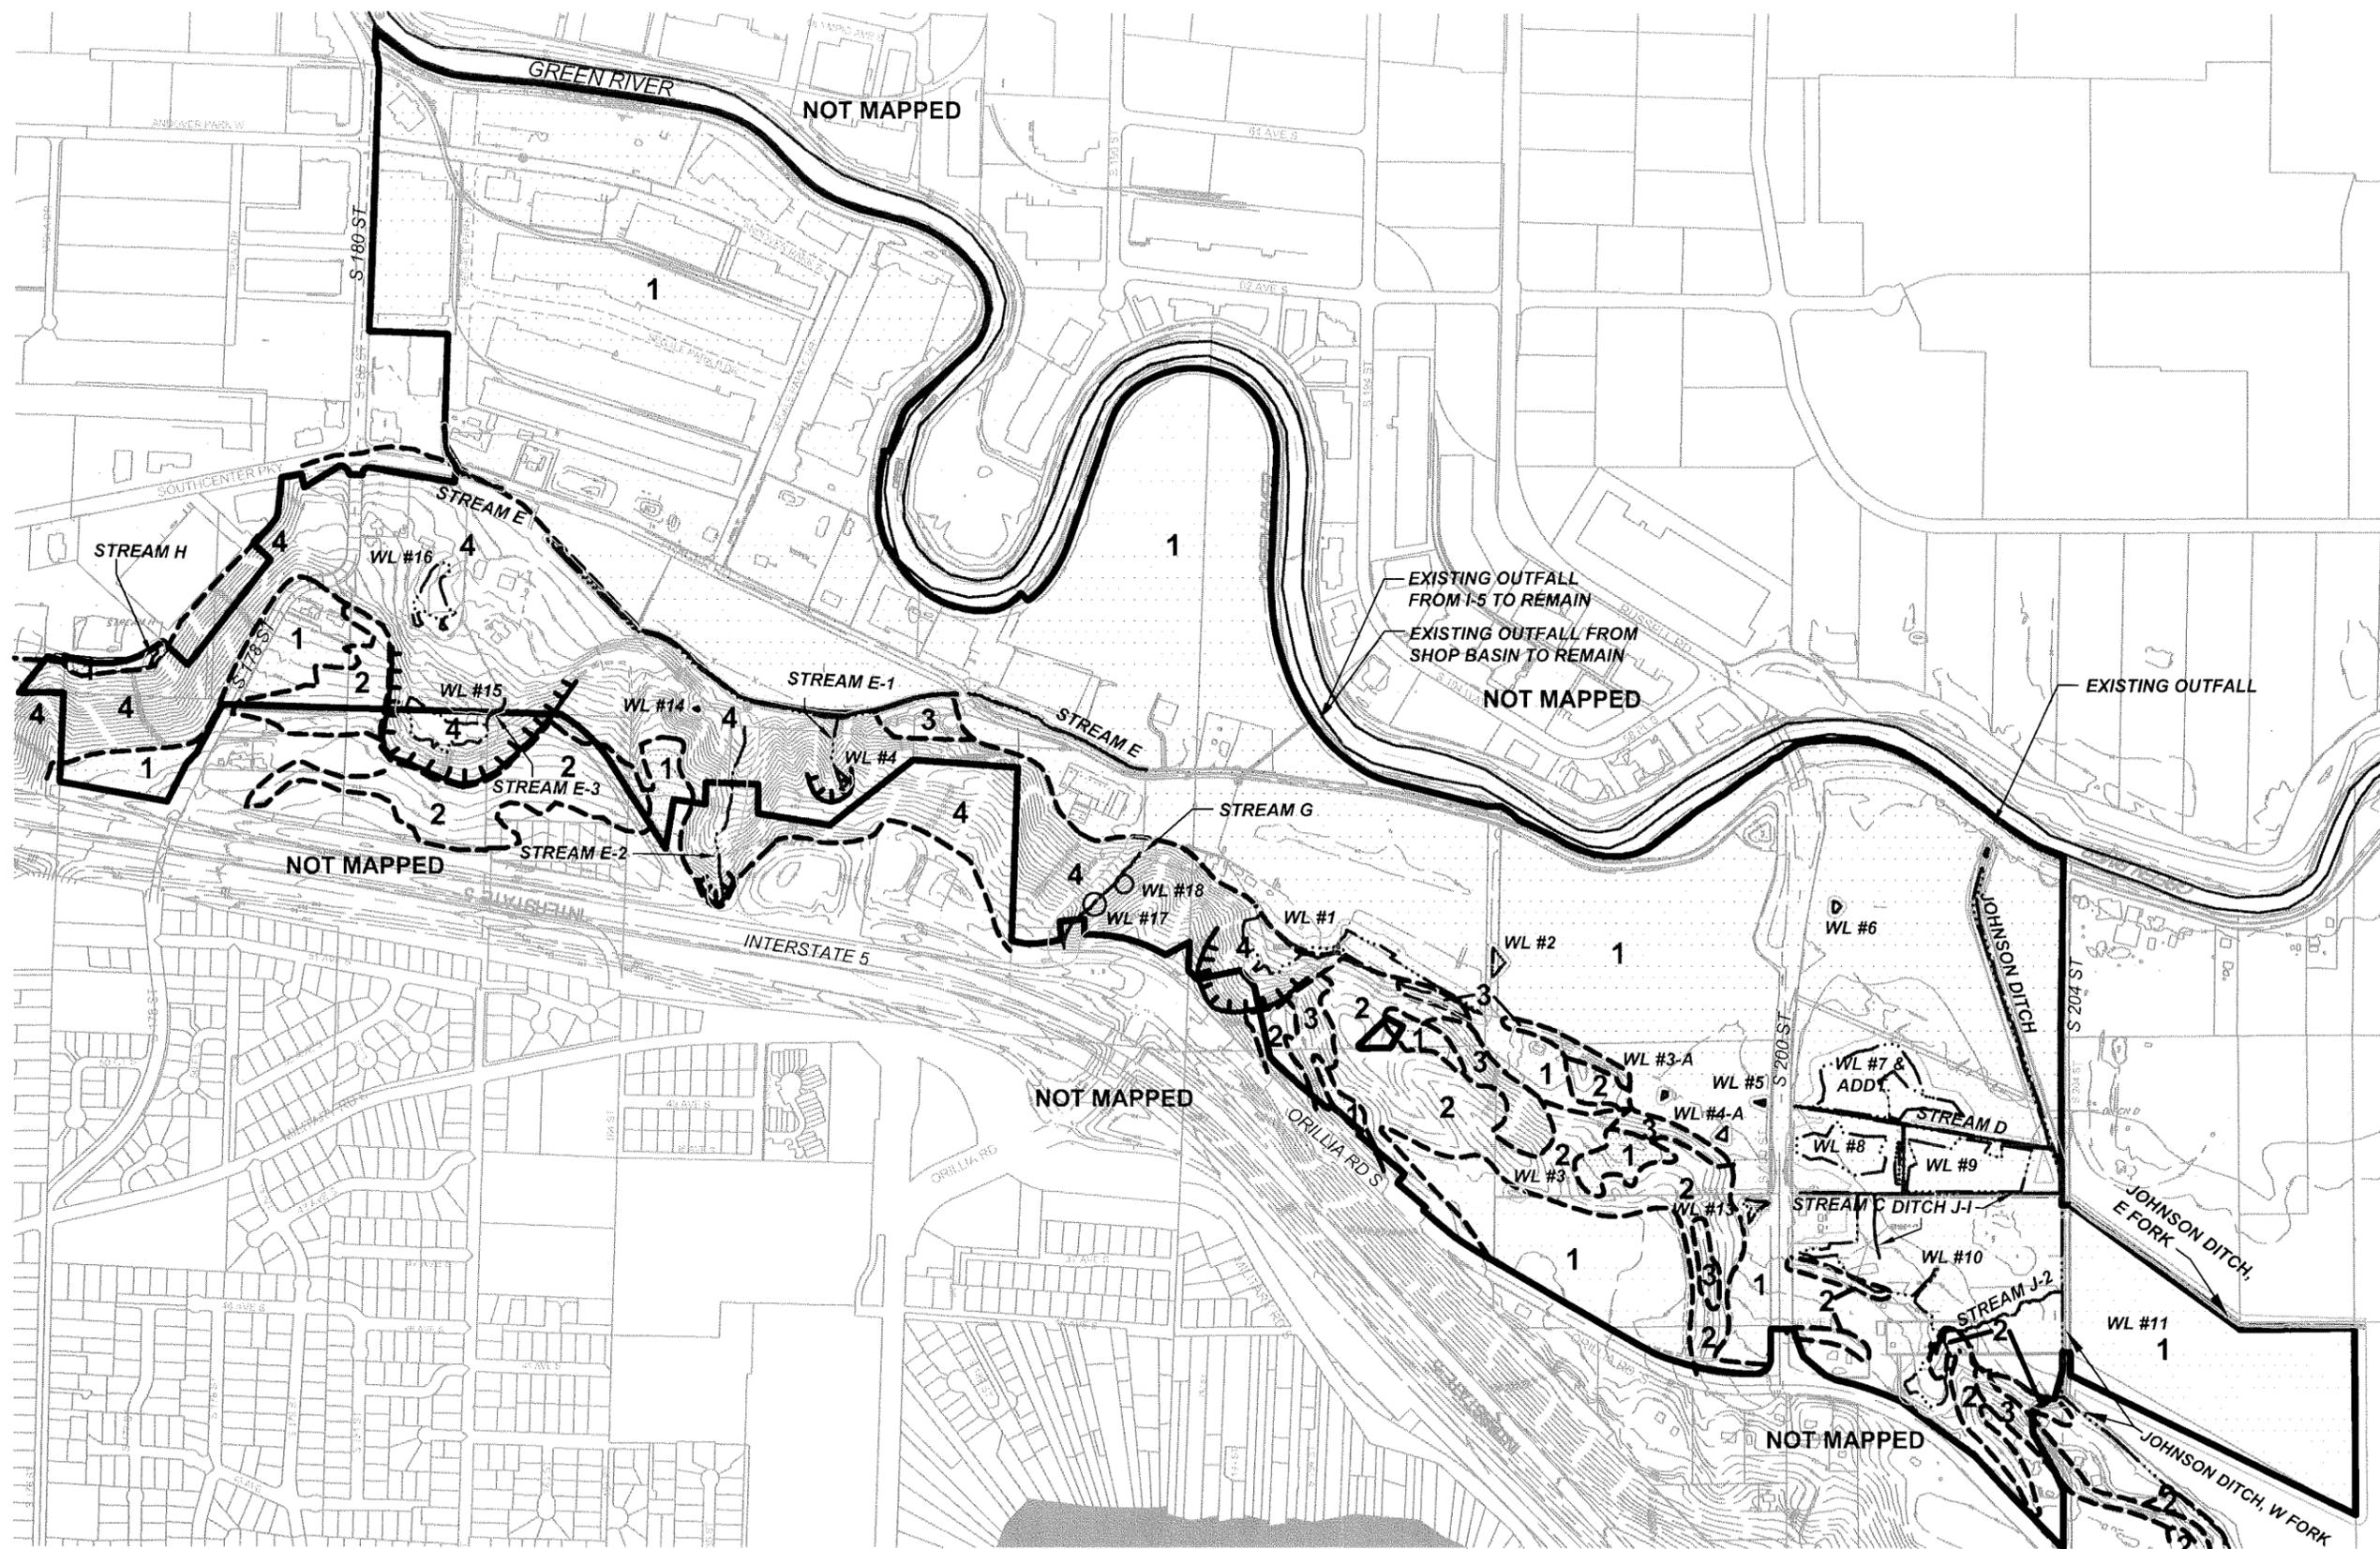
**LANDSLIDE HAZARD AREA LEGEND**

<b>1</b>	Class 1: Low risk		Existing slide scarp		Project boundary
<b>2</b>	Class 2: Moderate risk		Hazard contact line		Stream/ditch/wetland
<b>3</b>	Class 3: High risk			<b>WL #2</b>	Wetland No. 2
<b>4</b>	Class 4: Very high risk

1. Erosion hazard areas are related to the categories developed for landslide hazard areas per TMC 18.45.120A. Potential erosion hazard is generally low in Zone 1 areas and high in Zones 2, 3, and 4 areas.
2. The banks of the Green River are classified as Landslide Hazard Area Class 3: High Risk, but are too small to be shown at this map scale.
3. Offsite hazard area 1 is not delineated.
4. Roadway embankments associated with I-5, Orillia Road, South 200th Street, and South 178th Street may be in excess of 15%, but are not considered hazardous areas because they are engineered slopes.

Erosion hazard area categories are related to landslide hazard area categories, as defined by TMC 18.45. Potential erosion hazard is generally low in Class 1 landslide hazard areas and high in Class 2, Class 3 and Class 4 landslide hazard areas when vegetation is removed in these areas. Figure 3.1-2 shows landslide/erosion hazard classifications on the site.

An analysis of the existing landslide hazard potential on the site was conducted to identify landslide hazard areas. Hazard risks were subdivided into four categories per TMC 18.45, as described in Table 3.1-2 and shown in Figure 3.1-2.

Based on available information, the relatively flat valley bottom portion of the site is a low potential landslide hazard area (Class 1), with the exception of a narrow band along the Green River encompassing the steep slope river banks. This narrow band is Class 3 – high potential. The western slope is divided into three hazard areas: Class 2 - moderate potential; Class 3 - high potential; and Class 4 - very high potential (see Figure 3.1-2).

3.2, Water Resources and Appendix A for details). Because of the permeability of the Qvic sediments and the drainage collection system installed as part of mining/fill activities, the landslide hazard of the Qvic/QIs material is predominantly Class 2 with areas of Class 1 and 3 (see Figure 3.1-2).

A shallow debris flow occurred onsite in the Stream E-1 ravine (see Figure 3.1-2) following a record rainfall event in October 2003. Several small landslides are present near the head of the Stream E-2 ravine, and are interpreted to be caused by rapid stream/ravine incision related to runoff from the Bow Lake landfill prior to construction of I-5.
